INSPECTION REPORT

For the Property at:
5 ROBERT ROAD
PRESCOTT, ON K0E 1T0

Prepared for: GARY GREER
Inspection Date: Monday, December 7, 2020
Prepared by: TJ Smith

RE: Report No. 4921
5 Robert Road
Prescott, ON
K0E 1T0

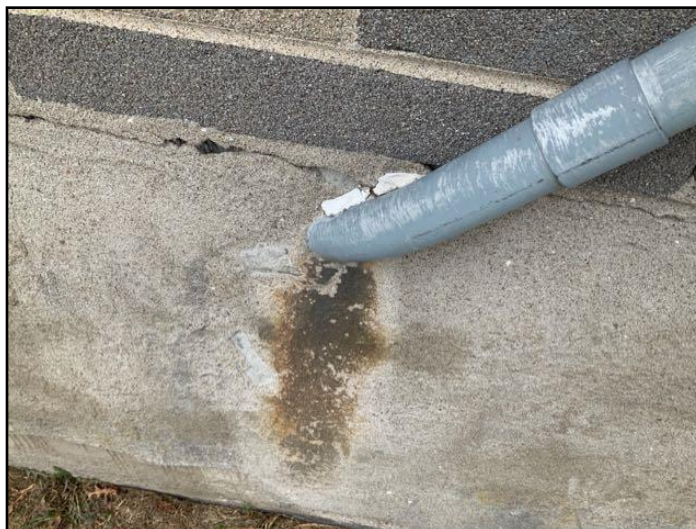
1. Condition: • [Caulking missing or ineffective](#)

It was noted that the caulking on various exterior walls was not optimal. It is recommended by the Inspector that any old/damaged caulking be removed and new caulking be applied as necessary, to prevent moisture/pest intrusion that can cause structural damage.

1. *Caulking missing or ineffective*

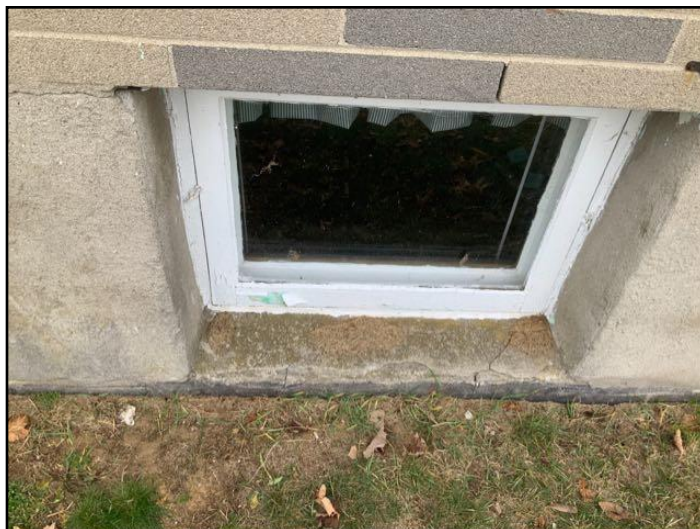
3. Condition: • [Paint or stain needed](#)

The window frames around the exterior of the home were in need of maintenance and new paint/stain. It is recommended to repair as required, then apply new paint/stain to all wood frames annually to protect the wood from premature deterioration due to moisture and insect intrusion.

2. Paint or stain needed

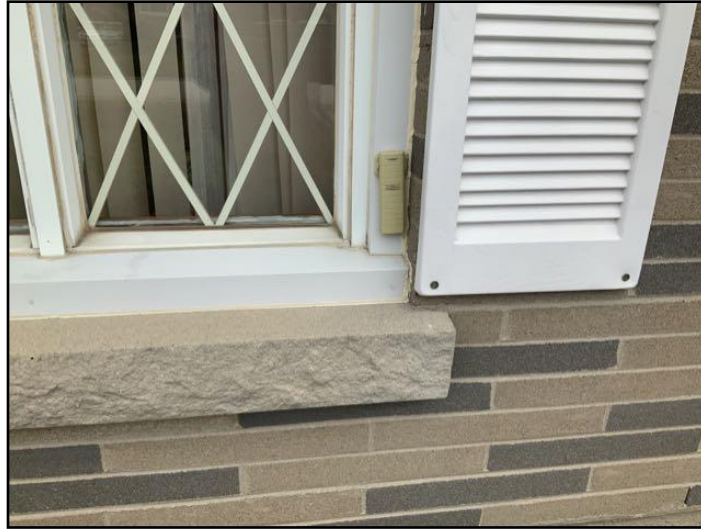
4. Condition: • [Caulking loose, missing or deteriorated](#)

During inspection, it was noted that the caulking around various windows of the exterior of the home was no longer effective. It is recommended by the Inspector to remove any old caulking and apply new caulking to all areas as required to prevent water/insect intrusion, and to decrease heating/cooling costs, while improving cosmetics.

3. *Caulking loose, missing or deteriorated*

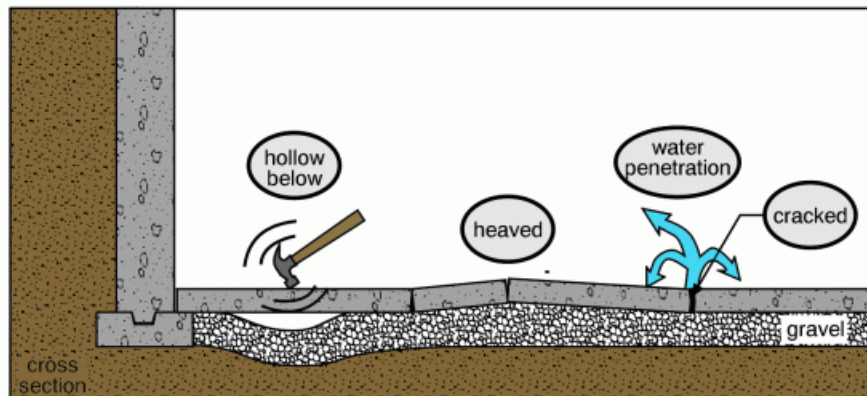
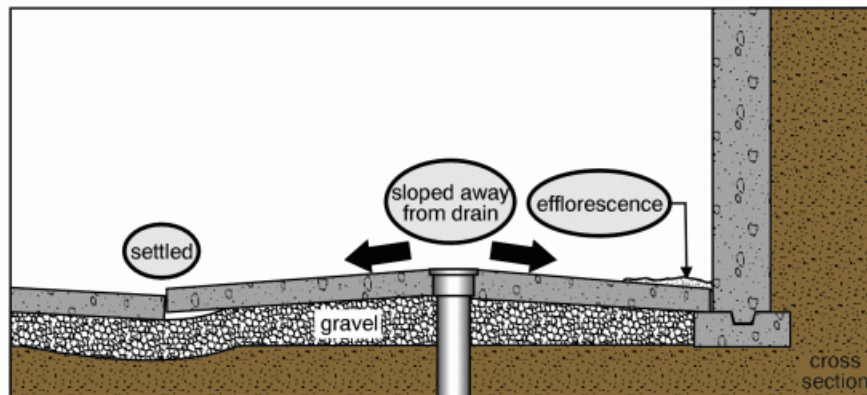
Concrete floor problems

5. Condition: • [Cracked](#)

Cracking was visible in the concrete floor that will need to be monitored and repaired as required. This type of cracking can have several causes:

- concrete shrinkage, which is a normal part of the concrete curing process and not a structural concern
- post-construction settling due to incomplete compaction of the soil beneath the slab during construction. This also is not an unusual condition and typically would not continue.

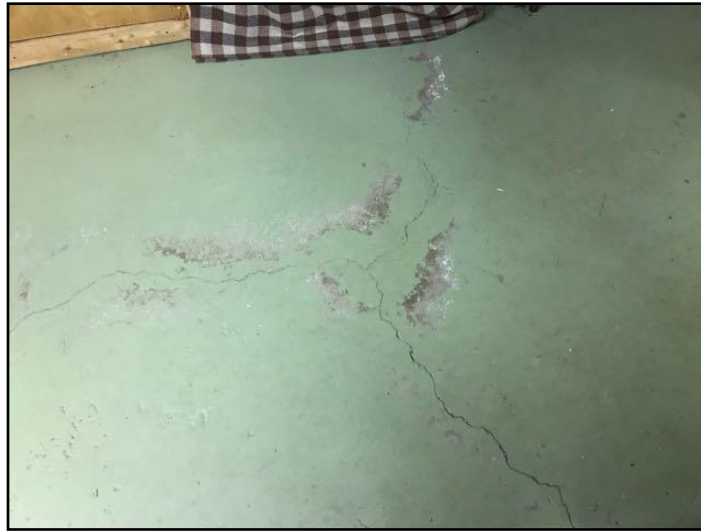
6. *Cracked*

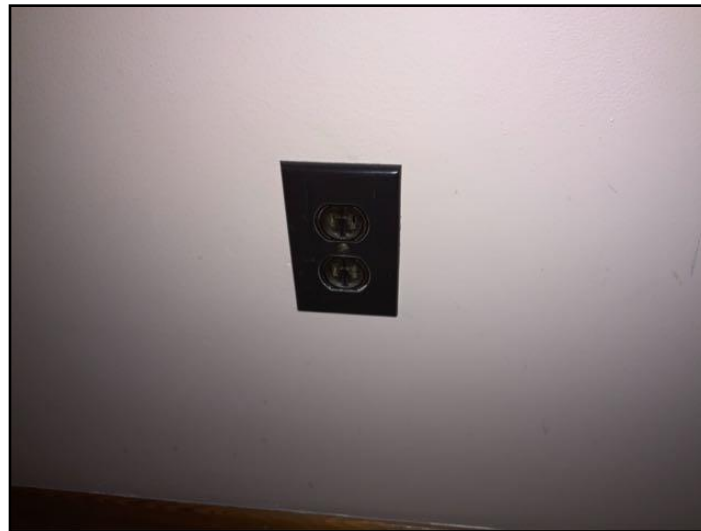
6. Condition: • [Ungrounded](#)

Several receptacles in the home were ungrounded. This happens when a three prong electrical outlet is installed without the ground wire being connected or the type of wiring used does not have a ground. While this is common for a home of this age, improvements are recommended.

10. *Ungrounded*

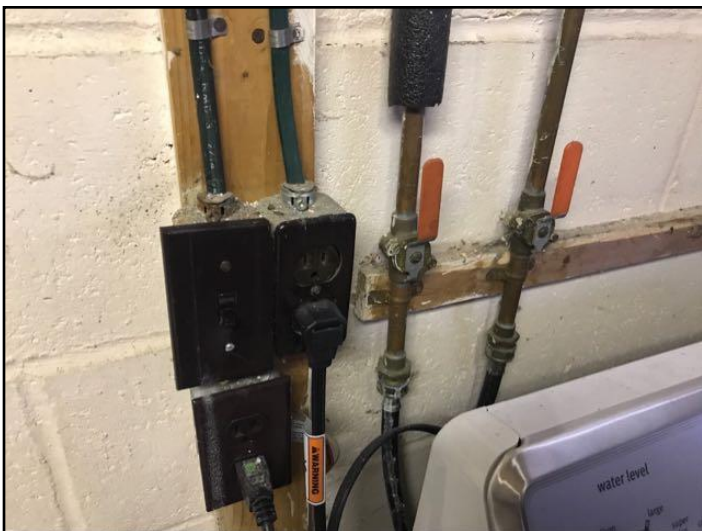
7. Condition: • Ground Fault Circuit Interrupter (GFCI) protection of home's electrical outlets were not present in various areas at time of inspection. Although GFCI protection may not have been required at the time the home was built, for safety reasons, consider upgrading the electrical system to include GFCI protection at the following locations:

11. Ground Fault Circuit Interrupter (GFCI)...

Consider having GFCI protection installed as a safety precaution.

1. Replacing the current standard outlets with GFCI outlets
2. Replacing the outlet in the garage circuit which is nearest the main electrical service panel with a GFCI outlet.
3. Replacing a non-GFCI breaker currently protecting an electrical circuit with a GFCI-type breaker.

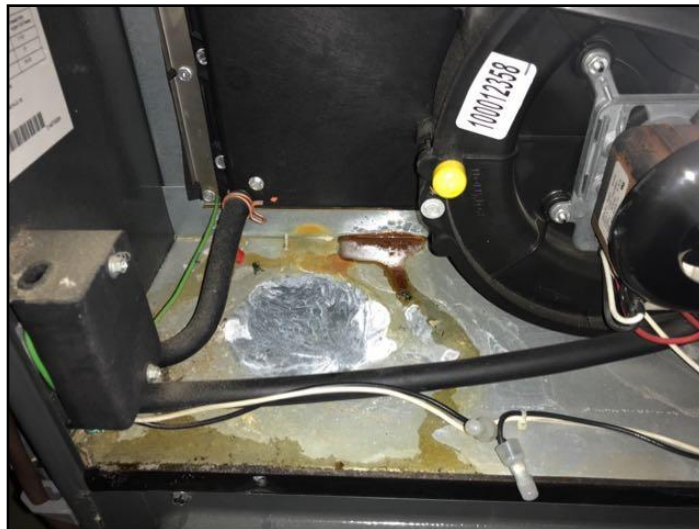
8. Condition: • [Rust](#)

The furnace cabinet had corrosion visible. The cause of the rust may be a damaged condensate line leaking into the cabinet. The Inspector recommends inspection and service by a qualified HVAC technician to ensure safe and efficient operating conditions exist.

15. Rust

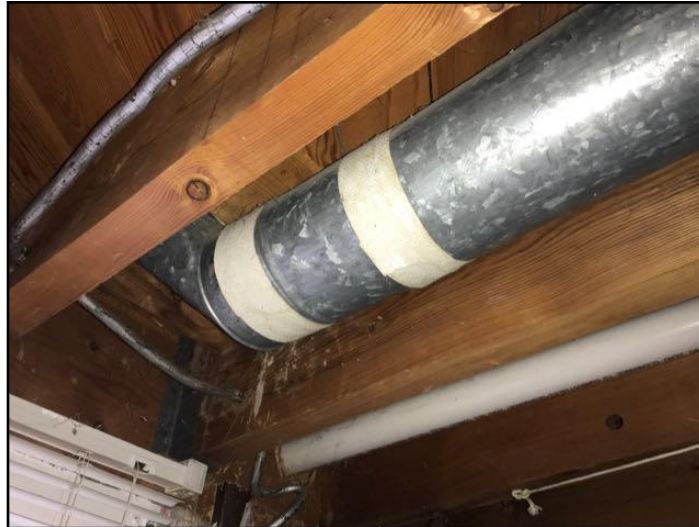
9. Condition: • The duct work in the basement was found to have some wrapping on it that has been known at times to contain asbestos. The only way to know for certain whether asbestos is in a particular product or material is to have testing performed.

16. The duct work in the basement was found to...

Consider having an asbestos screening performed before the expiration of your Inspection Objection Deadline. If asbestos is found, you will be required to disclose its presence if you offer the home for sale. It is recommended that it be properly removed from the home by qualified technicians.

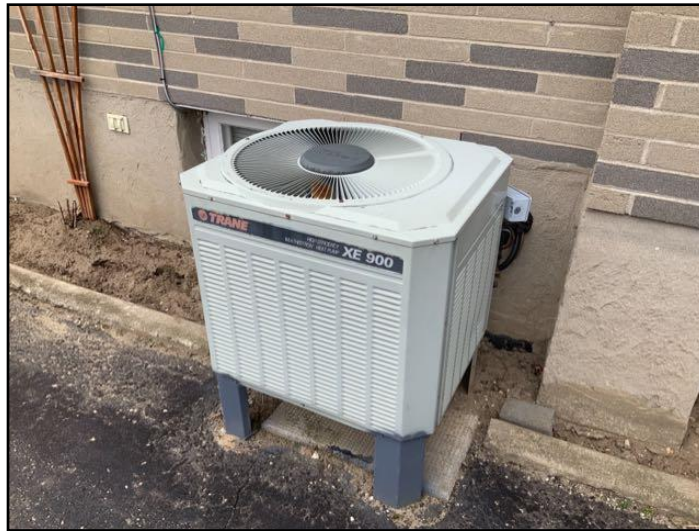
11. Condition: • Service air conditioner

18. Service air conditioner

The air conditioner in the exterior should be serviced and cleaned by a qualified technician to ensure it is running at maximum efficiency.

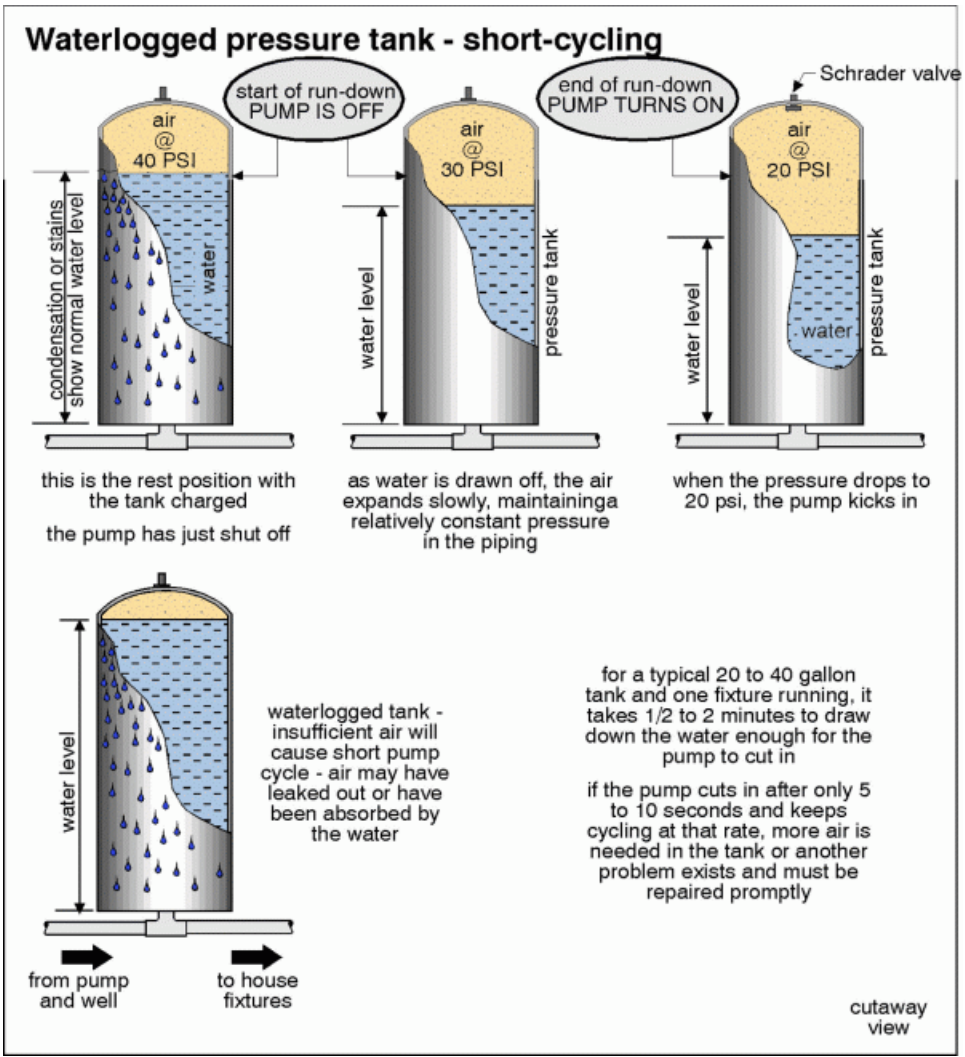
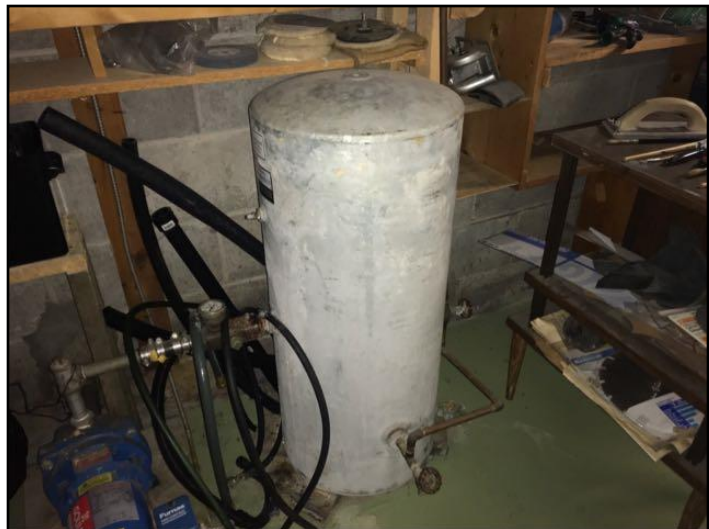
12. Condition: • [Waterlogged](#)

The pressure tank was found to be water logged and no air was present inside of the pressure tank. The pressure tank needs to be replaced.

22. Waterlogged

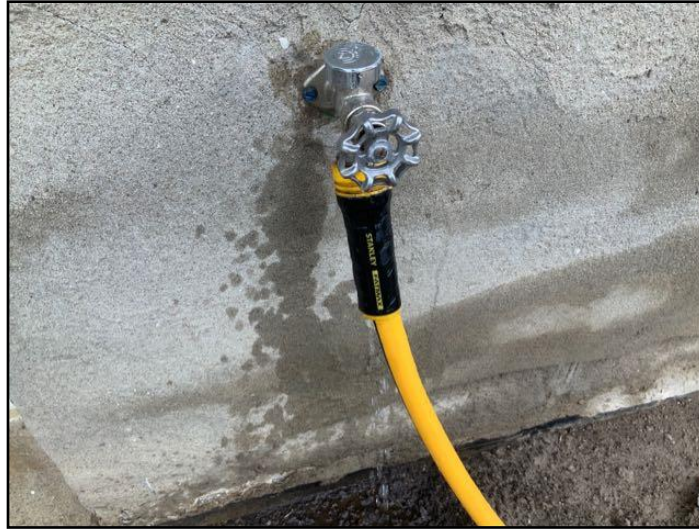
13. Condition: • [Leak or drip](#)

The exterior hose tap was found to be leaking at the time of inspection. It is recommended to have it repaired or replaced.

23. Leak or drip

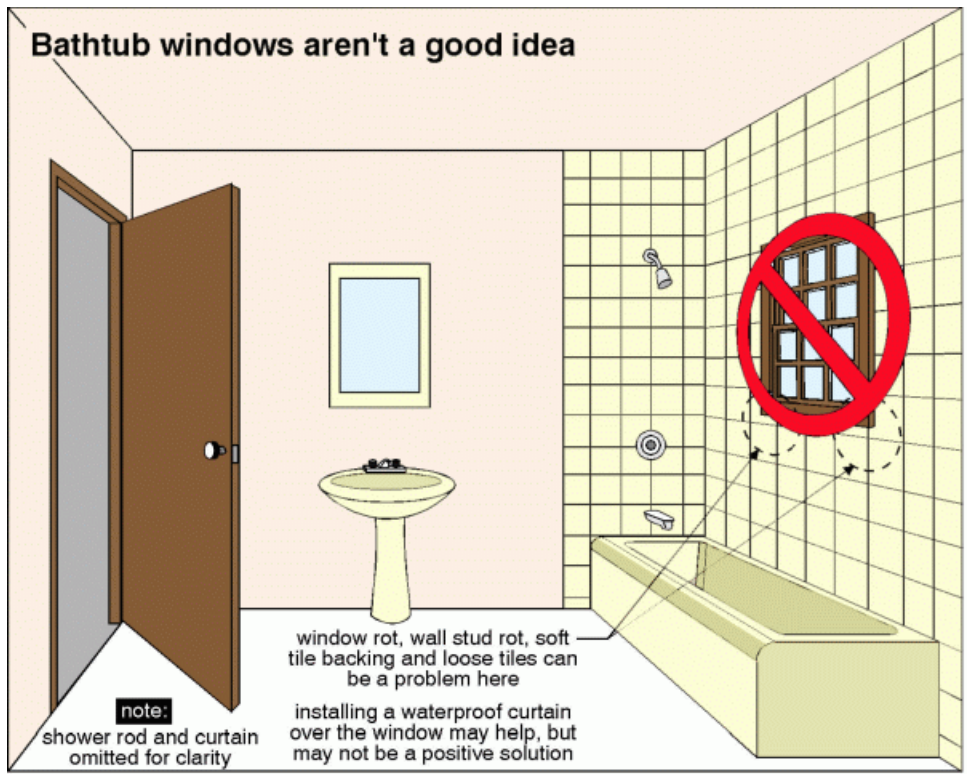
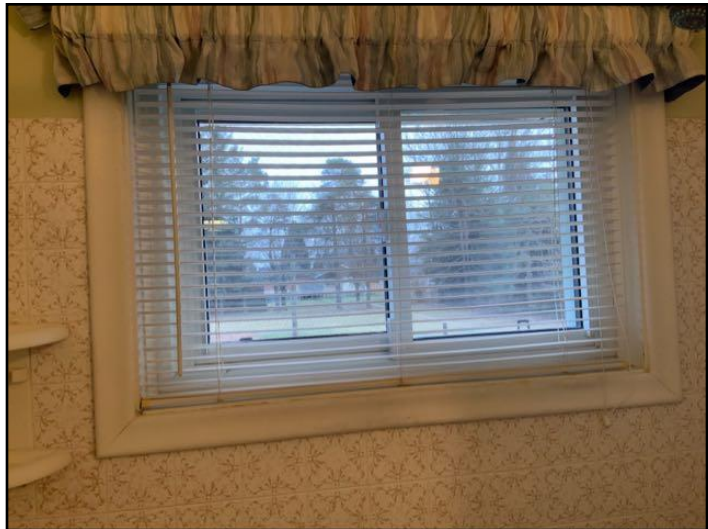
14. Condition: • The bathroom of the home has an unprotected window. The trim around the window and tub surround is susceptible to moisture intrusion. This should be regularly monitored and proper steps taken to ensure water and moisture intrusion does not occur into the wall assembly.

24. The bathroom of the home has an unprotected...

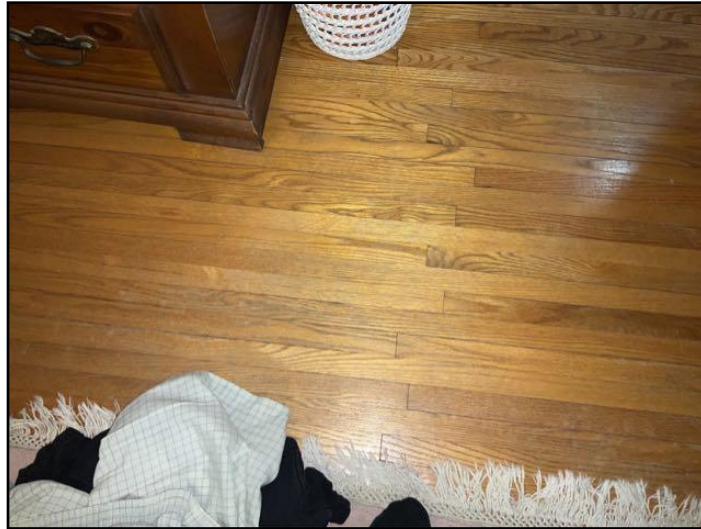
15. Condition: • Various areas of the flooring was worn. To avoid hygiene issues while improving cosmetics, a qualified flooring contractor will need to repair.

27. Various areas of the flooring was worn. To...

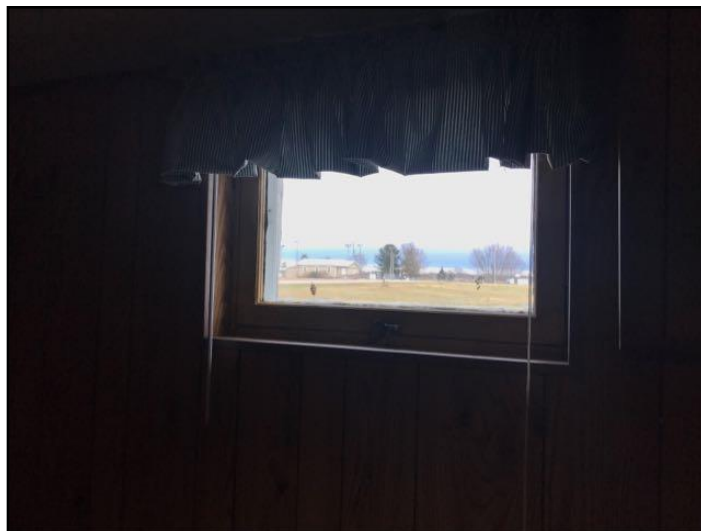
16. Condition: • [Original lower quality units](#)

During inspection it was noted there were original lower efficiency windows in the home. To decrease heating/cooling costs and improve home comfort they should be repaired or upgraded to higher efficiency windows.

28. Original lower quality units

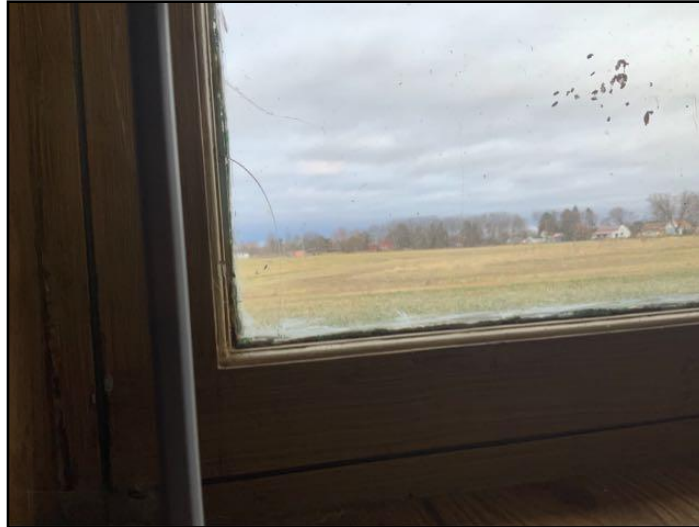
17. Condition: • [Cracked](#)

Various windows of the home were cracked. These should be repaired or replaced as required by a qualified contractor to avoid injury and improve efficiency.

29. Cracked

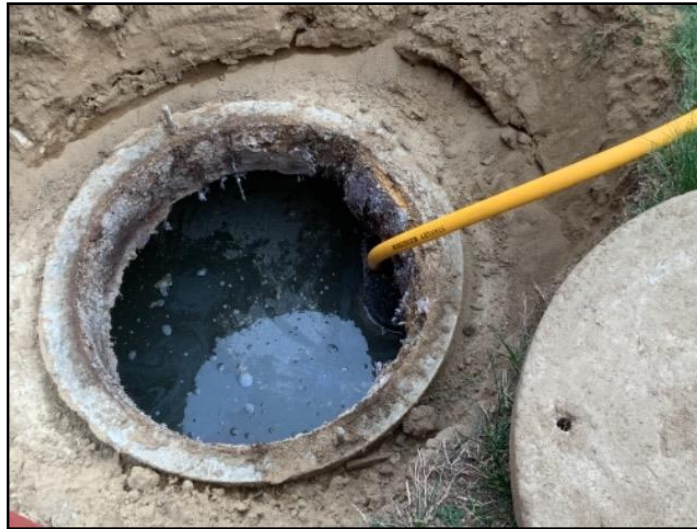
18. Condition: • Deteriorated

There was minor deterioration noted around the opening of the tank. which should be monitored and repaired when required. This should be done to avoid contamination of the soils and allow the system to run efficiently.

30. Deteriorated

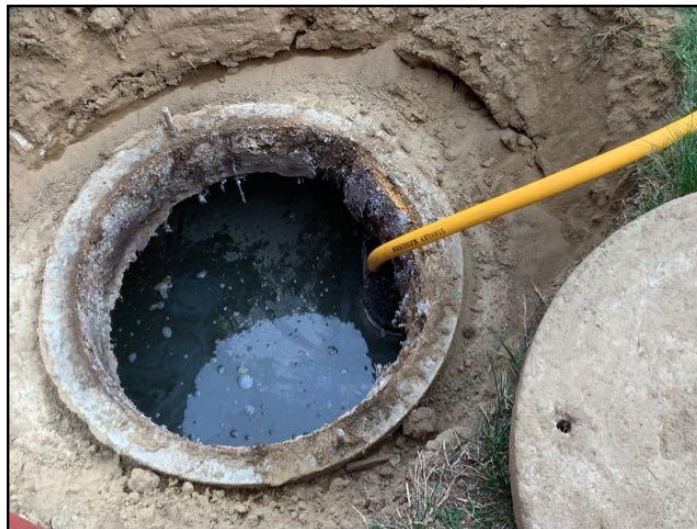
20. **Condition:** • It is recommended to have an effluent filter installed on the outlet baffle of the septic tank. This will prevent small particles from entering the leaching field and possibly blocking the leaching field materials. The filter should be inspected and cleaned at least once a year.

31. It is recommended to have an effluent filte...
